DEPARTMENT OF TRANSPORTATION**DIVISION OF ENGINEERING SERVICES**

Quality Assurance and Source Inspection

Contract #: 04-0120F4Cty: SF/ALA Rte: 80 PM: 13.2/13.9File #: 13.28**WELDING INSPECTION REPORT****Resident Engineer:** Pursell, Gary**Address:** 333 Burma Road**City:** Oakland, CA 94607**Report No:** WIR-014701**Date Inspected:** 10-Jun-2010**Project Name:** SAS Superstructure**OSM Arrival Time:** 1000**Prime Contractor:** American Bridge/Fluor Enterprises, a JV**OSM Departure Time:** 1830**Contractor:** Oregon Iron Works Clackamas, Or.**Location:** Clackamas, OR

Hinge-K Pipe Beam Assembly 101A-3:

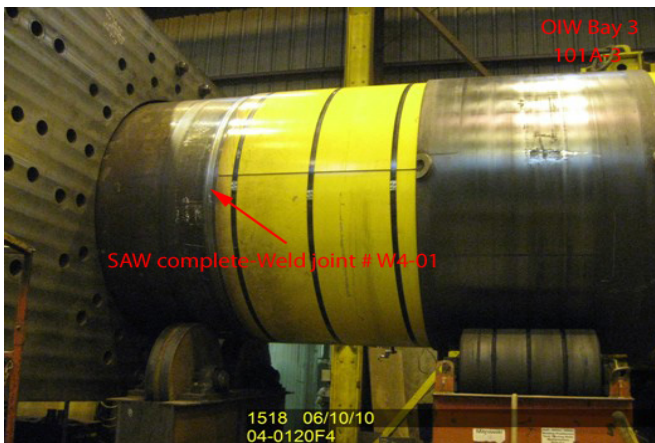
The QA Inspector observed WID #S53 (Jerry Shepherd) currently in process of performing the submerged Arc Welding (SAW), on the Weld Joint #W4-01. The QA Inspector noted that this Complete Joint Penetration (AWS D1.5 B-U7-S), was the Fuse 120A-3 to Forging 102A-3 and that the SAW was being performed from the exterior of the weld joint in the flat position. The QA Inspector observed that continuous pre-heat was being applied utilizing 2 previously set up stationary rosebud torches, on the outside of the weld joint.

The QA Inspector later observed that the SAW had been completed and the assembly was currently idle, pending the 72 hrs. cooling time, prior to Ultrasonic Testing (UT). See attached pictures below.
